Docket No. 217 – Development and Management Plan Inspection

Northeast Utilities Service Company Certificate of Environmental Compatibility and Public Need for the construction of a 345-kV electric transmission line and reconstruction of an existing 115-kV electric transmission line between Connecticut Light and Power Company's Plumtree Substation in Bethel, through the towns of Redding, Weston, and Wilton, and to the Norwalk Substation in Norwalk, Connecticut.

Date: April 6, 2005

Location: Norwalk Substation Expansion

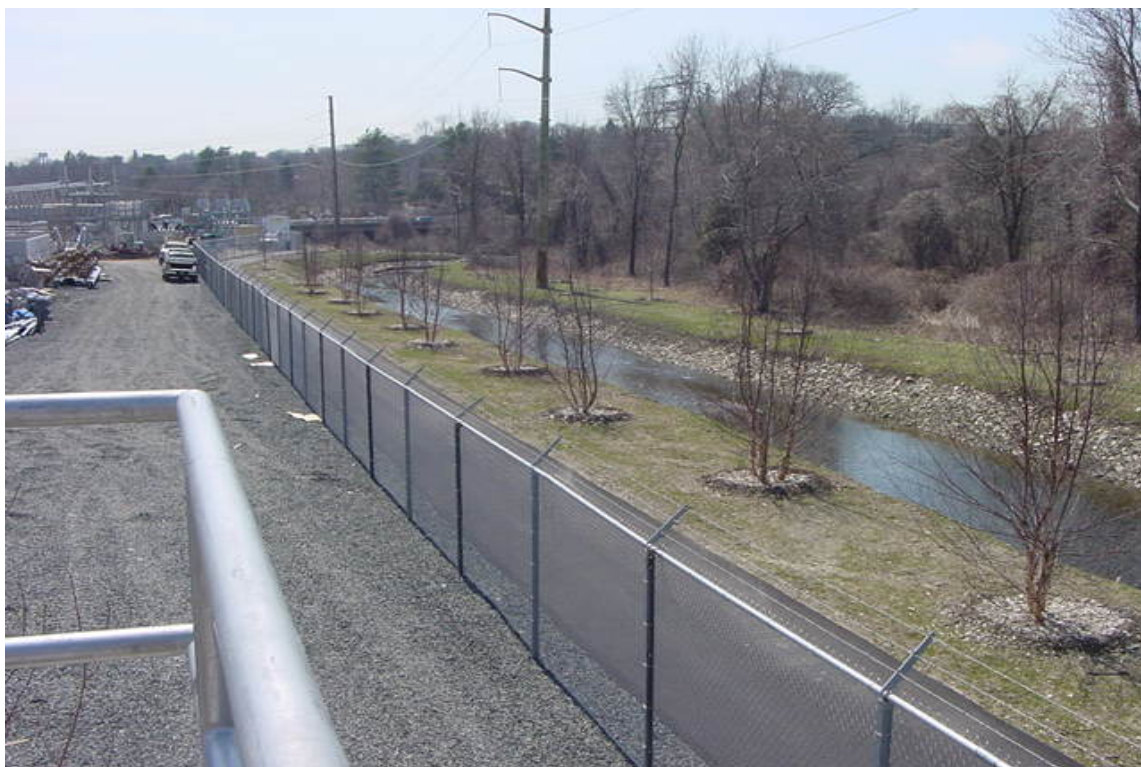
Norwalk Substation: Overflow Channel continues to work well with additional rains. (4/6/05)

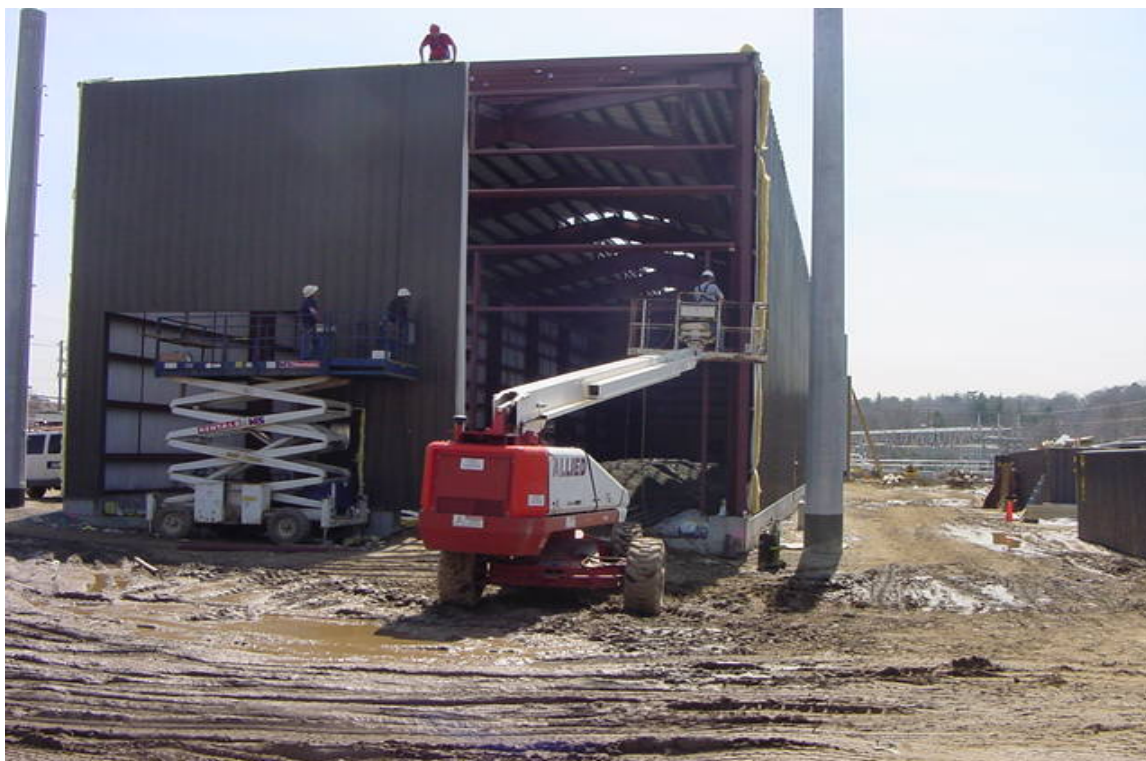
Siding work continues on the GIS Building (4/6/05)

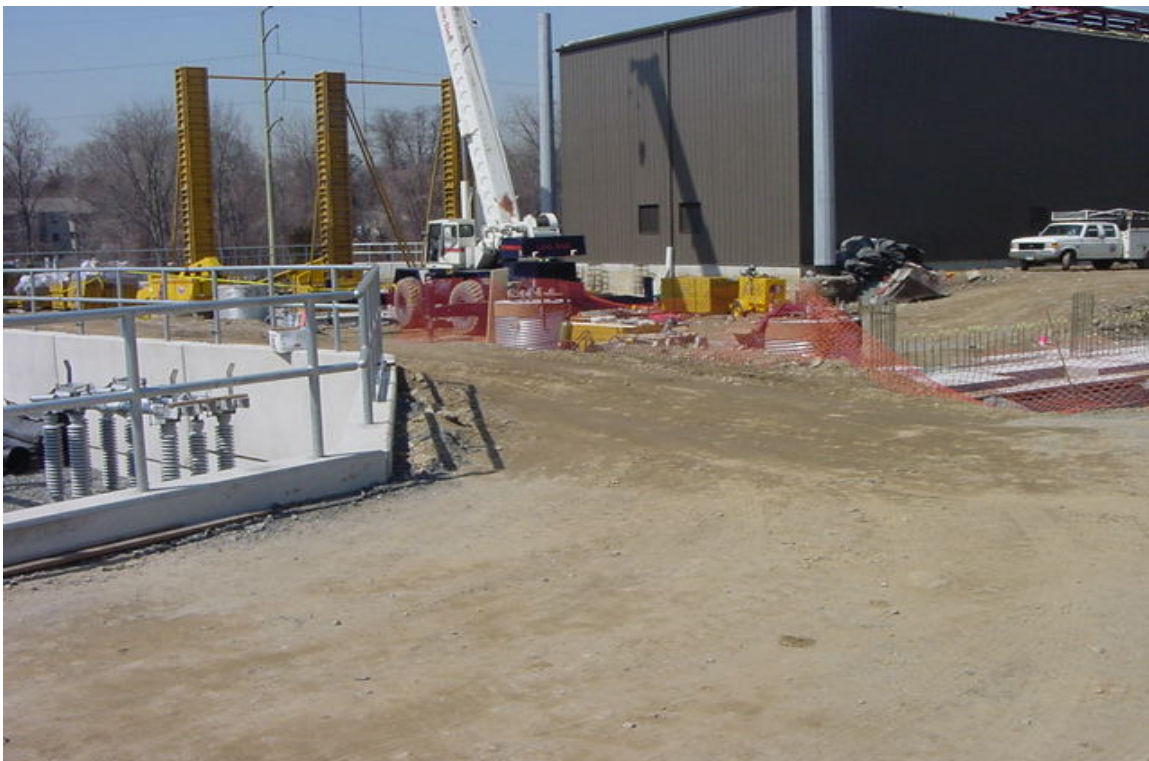
Structure work continues near retaining wall #3 and the control house. (4/6/05)

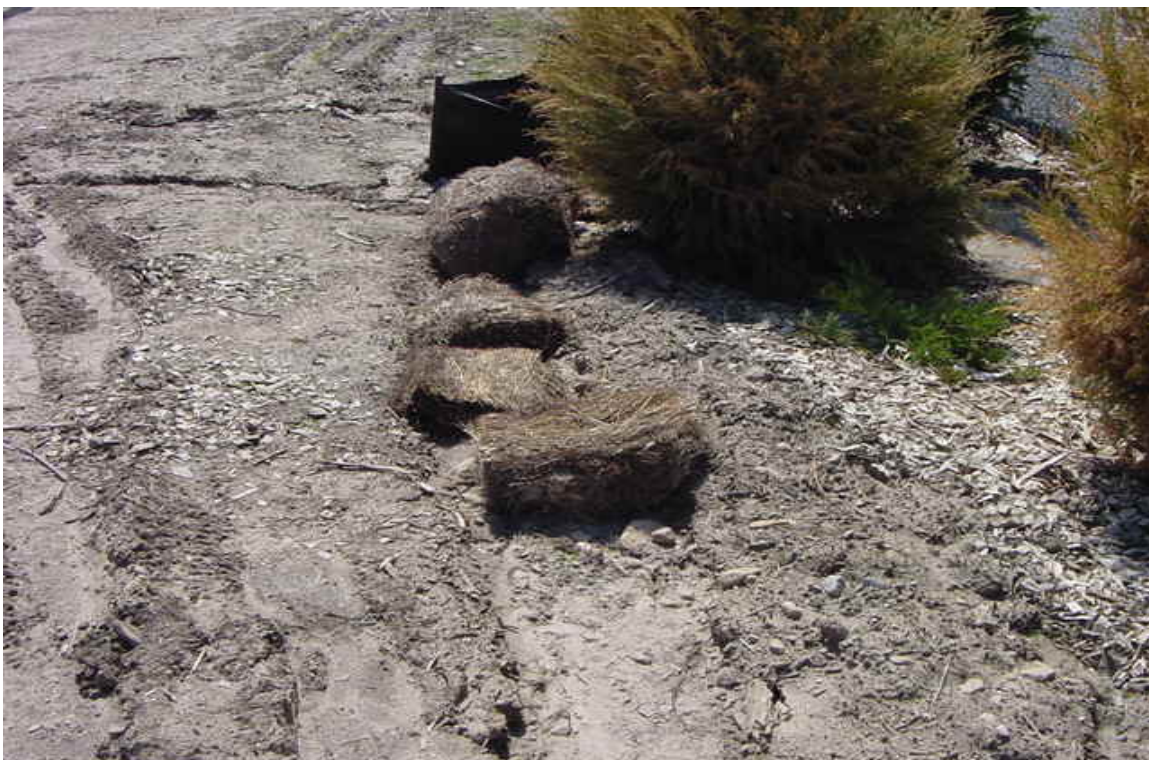
<ul style="list-style-type: none"> - The flared inlet near the Rt 7 ramp is receiving obvious stormwater flows from off site roadway and on site sources. It is apparent that much of the sediment is roadway sand and much of the runoff is from the street based on presence of gullies. The silt fence was ripped down as a result of the recent storms. Haybales were placed but runoff volume is high. 4/6/05 	<ul style="list-style-type: none"> - Continue to monitor until stabilized as the surrounding area is still bare soil. Part of the sedimentation is from offsite street runoff which cannot be controlled by onsite actions. The best solution here is revegetation in the growing season. 4/6/05
	<ul style="list-style-type: none"> - Some excavation and backfill is finishing up in several areas throughout the site. Soil stockpiles are beginning to be removed from site to appropriate locations. 4/6/05 	<ul style="list-style-type: none"> - All stockpiles and excavation areas are well within the site and there are no issues at this time. 4/6/05

Drainage swale with haybales at inlet located near the Route #7 ramp. This area should be revegetated as soon as possible (4/6/05)

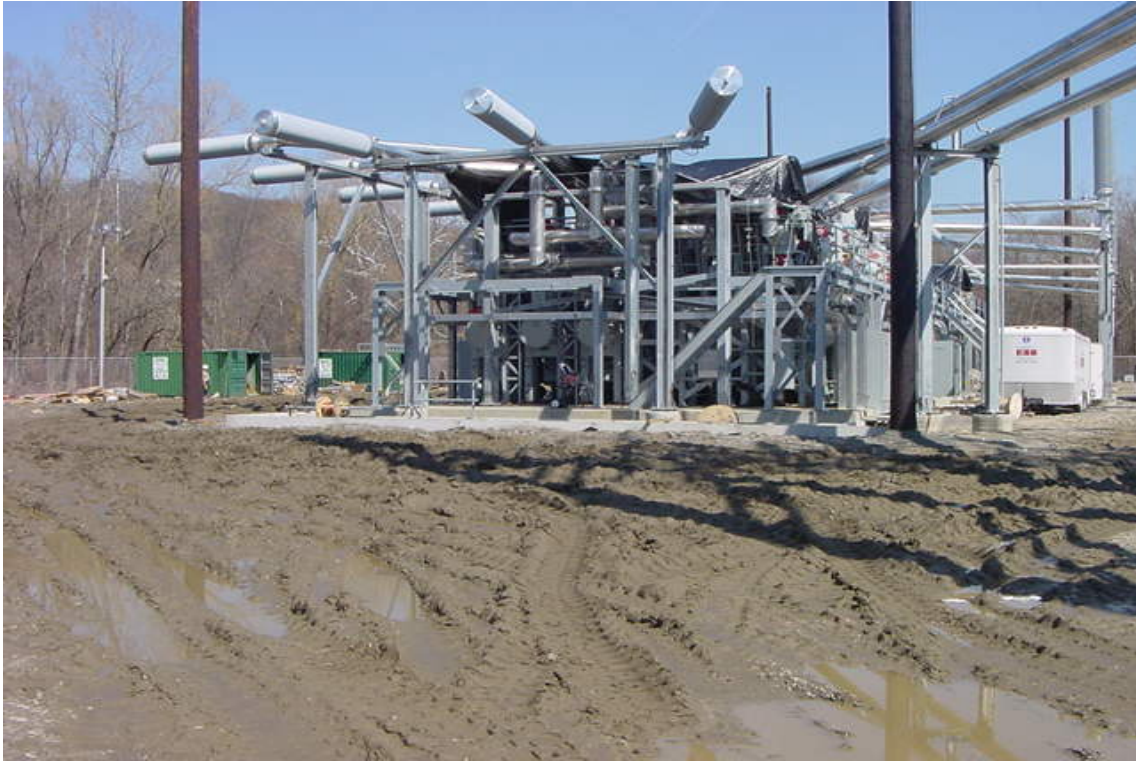
Plumtree Substation: Internal work continues on the slab. (4/6/05)

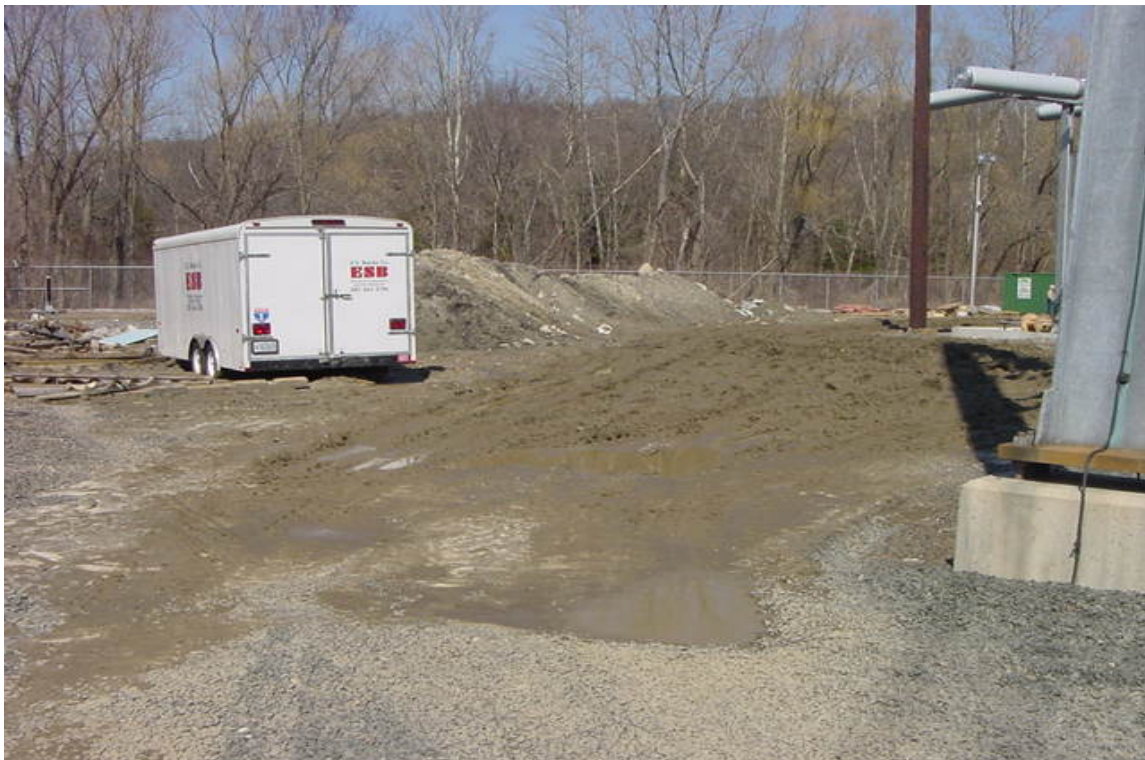
Areas of Inspection	Observation	Recommended Action
	- A majority of the soil has been removed to appropriate off-site locations but some will remain on an as needed basis for the remainder of construction. Portions are not covered in plastic but are well within the site. 3/2-4/6/05	-Continue to monitor status and cover stockpiles with plastic if necessary. 3/2-4/6/05
Inland Wetland and Watercourse encroachment and mitigation	- Wetlands are located around the outskirts of the substation yard. The work within the substation yard has caused no observed sedimentation. 4/6/05	- The stone berm around the perimeter of the yard continues to prevent sedimentation and water from leaving the site and getting to the wetland edge. 4/6/05
State species of concern, threatened and endangered species	- No species of concern are located in this area of construction.	- N/A
Vegetative clearing limits (including trees to save or danger trees noted)	- No vegetation outside of the substation yard will need to be cleared during the expansion work.	- N/A

View of the yard with the leftover stockpiles. Very little work involving soil disturbance is occurring at this time. (4/6/05)
